ILLINOIS ENVIRONMENTAL PROTECTION AGENCY

Re: LPC # 1358070001-- Montgomery County
Hillsboro/Eagle Zinc
ILD #980606941
Compliance File

Narrative

Date of Inspection: March 29, 2001

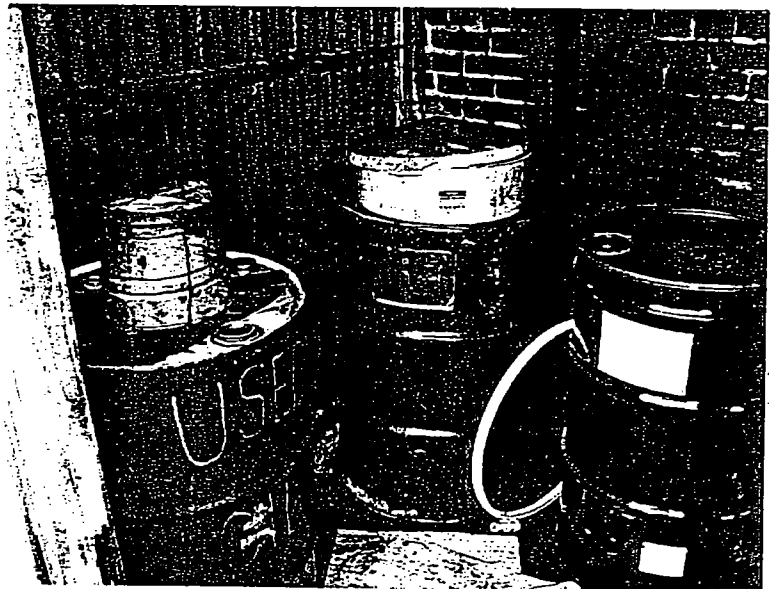
estimated to be 24 inches by 24 inches and held about 6 inches of solvent. This was figured at about 15 gallons. Oil changes from vehicles at the shop and from machinery around the facility are accumulated in 55-gallon drums. A locked shed on the west side of the Electrician's Shed accumulates the used oil. Inside the shed were 1 full drum of used oil, a partially full 55-gallon drum with used oil, a 55-gallon drum for accumulating oily rags, and a drum for accumulating spent oil filters (see photo 2). The used oil drums were marked with the wording "Used Oil." Mr. Youngless said the automotive shop does not normally engage in changing tires or generating used or waste tires. Spent vehicle batteries from Eagle Zinc are accepted at McKay's Auto Parts in Hillsboro.

DATE: March 29, 2001
TIME: 9:45 am
DIRECTION: Northeast
PHOTO by: Richard Johnson
PHOTO FILE NAME:
1358070001~03292001-002
COMMENTS: Photo shows drums of
used oil being stored in a small room off
of the automotive shop.

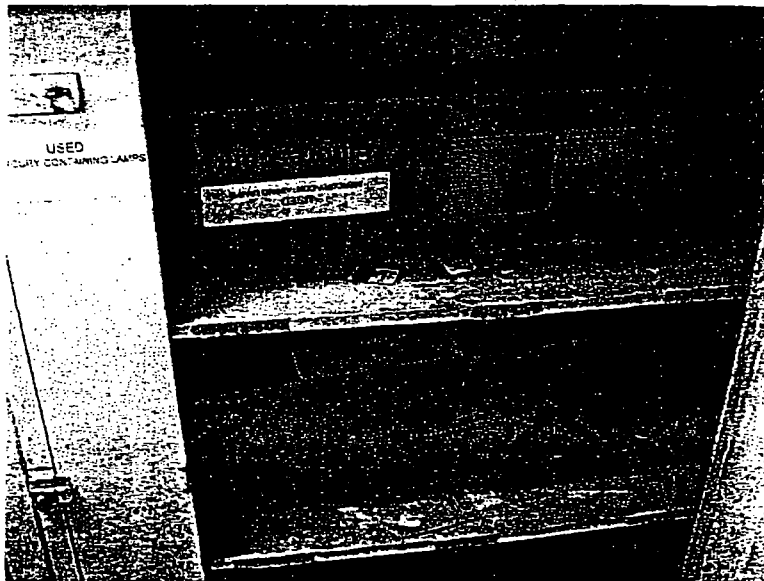
DATE: March 29, 2001
TIME: 10:05 am
DIRECTION: South
PHOTO by: Richard Johnson
PHOTO FILE NAME:
1358070001~03292001-003
COMMENTS: Photo shows 2 boxes of
used mercury containing lamps in a
room of the maintenance shop.
